# AUDELIA ROAD BRANCH LIBRARY

## Building Infrastructure: Assessments & Recommendations

**AUDELIA ROAD  
BRANCH LIBRARY**  
 Planning & Design:  
 Assessments  
 & Recommendations

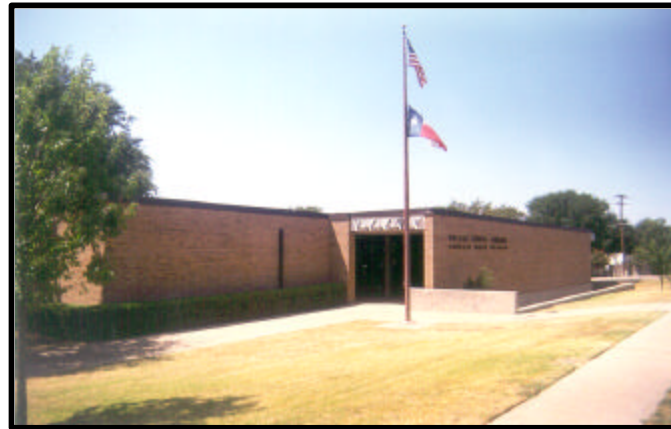
View of the entrance

- The entrance is dark and looks cave-like.

- New additions will increase potential for visibility with windows looking out to the parking lot.

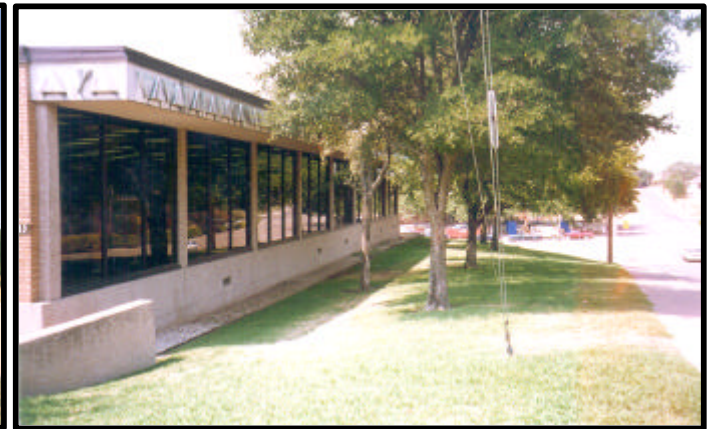
View along the street

- The hidden entry fails to provide views of the activity inside.

- Open the views to the south and add a north facing light monitor over the central public space.

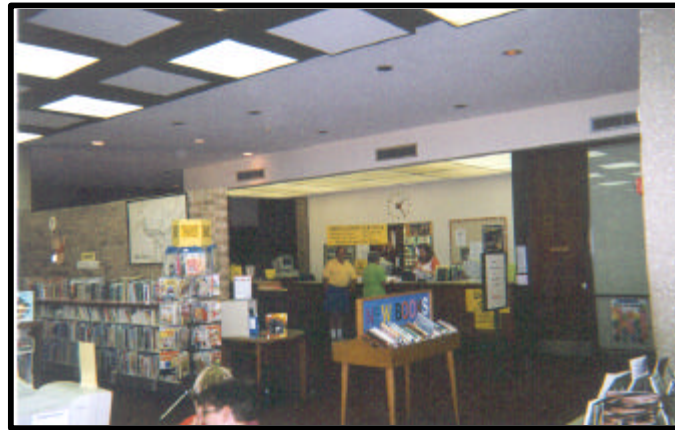
View of the circulation desk

- The view of the adult areas is blocked by the Manager's office.

- Relocate the manager's office to the staff lounge area.

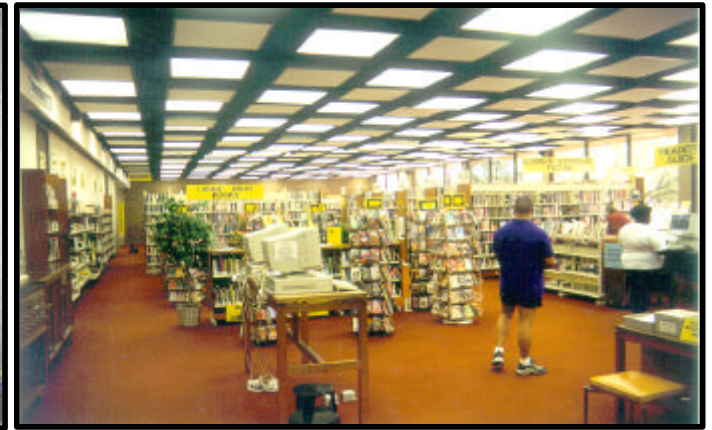
View of the reading room
