CASA VIEW BRANCH LIBRARY

Building Infrastructure: Assessments & Recommendations

**CASA VIEW
BRANCH LIBRARY**
Planning and Design
Assessments
& Recommendations

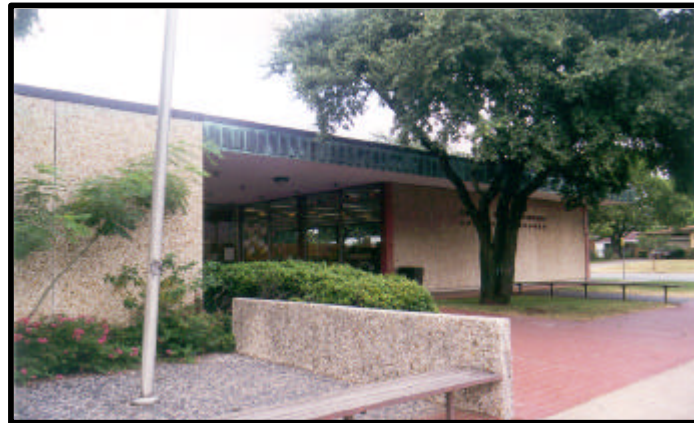
View of the entrance

- The entrance is remote from the parking lots.

- The new entrance should be welcoming, easily accessible, and clearly visible to staff.

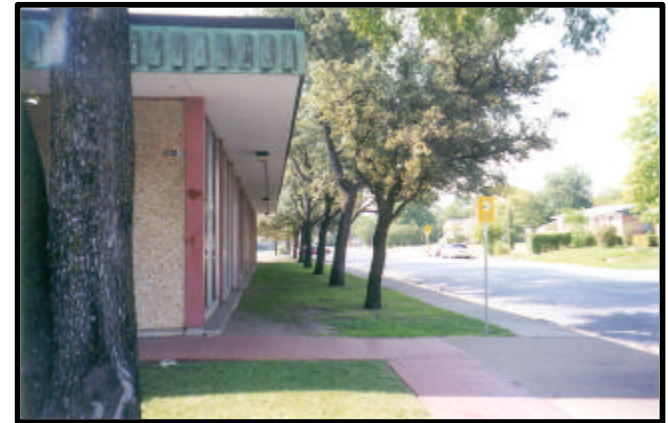
View along the street

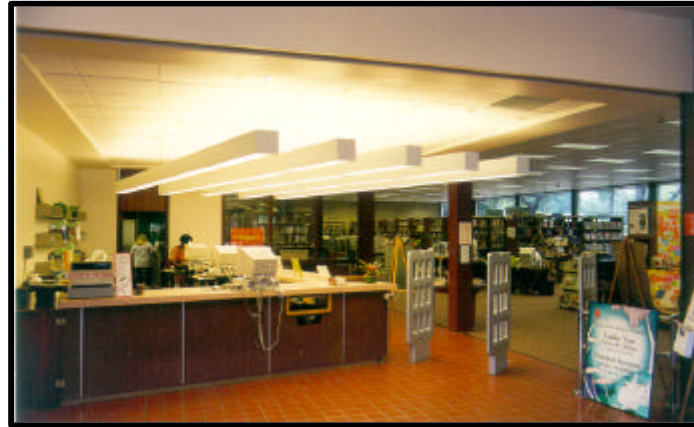
View of the circulation desk

- The auditorium and toilets cannot be viewed from the desk.

- The new facility should have a well-placed central desk with good sight lines.

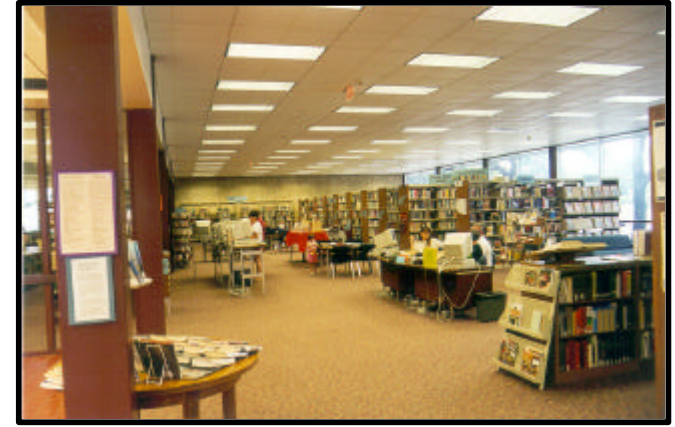
View of the reading room

- The adult seating is crowded and not near windows.
There are too few P.C.'s and the stand-up stations are tight.

- Create a new "Reference/Computer Area" with PC's, power/data ports for laptops, and a central periodicals reading area.
