# FRETZ PARK BRANCH LIBRARY

## Building Infrastructure: Assessments & Recommendations

**FRETZ PARK  
BRANCH LIBRARY**  
Planning and Design:  
Assessments  
& Recommendations

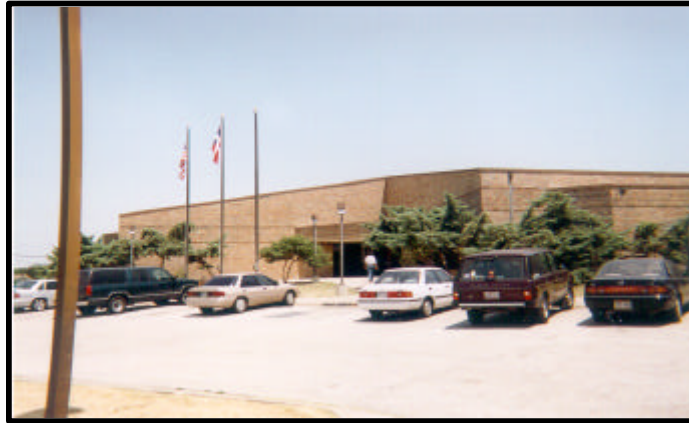
The building has an institutional scale and image appropriate for its location near park land and a recreation center. A new addition could make it look more inviting.

View of the entrance

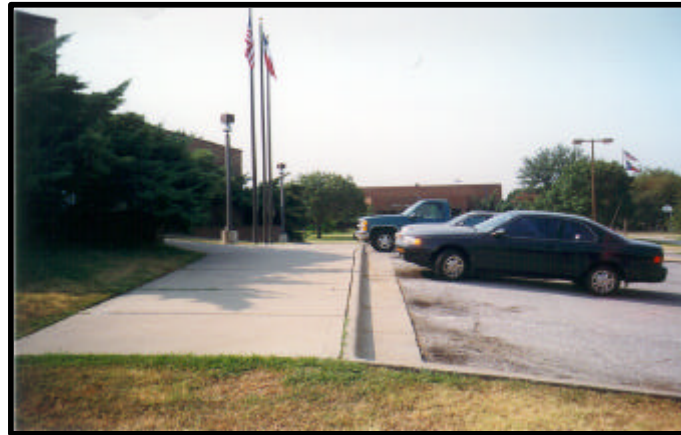
View of the parking lot

- PARKING**
  - Parking is shared with the Recreation center, and the lot is full before the Library opens on Saturdays.
- ENTRANCE**
  - The storefront doors are heavy and hard to operate.

- PARKING**
  - Improve the signage to prevent parking lot congestion.
- ENTRANCE**
  - Refurbish the doors with new ADA compliant hardware.
- CIRCULATION DESK**

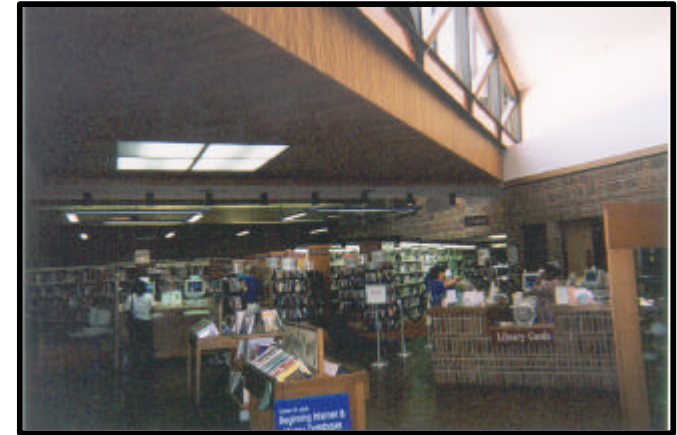
View of the reading room

- DISPLAYS**
  - The displays are small and not well lighted.
- ADULT AREA**
  - This area is small and lacks seating and P.C.'s.
- CHILDREN'S AREA**
  - The children's area is large, but the YA floor is recessed, and not ADA compliant.

- DISPLAYS**
  - Consider adding new interactive display units with integral lighting.
- ADULT AREA**
  - Place the periodicals in a more visible area, close to seating. Use center area for added seats and P.C.'s.
