PARK FOREST BRANCH LIBRARY

Building Infrastructure: Assessments & Recommendations

**PARK FOREST
BRANCH LIBRARY**
Planning and Design
Assessments
& Recommendations

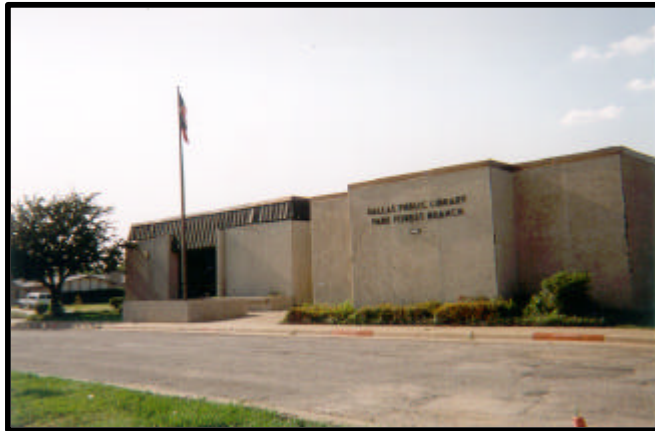
The building presents an unattractive civic image. It appears dated and tired.

View of the entrance

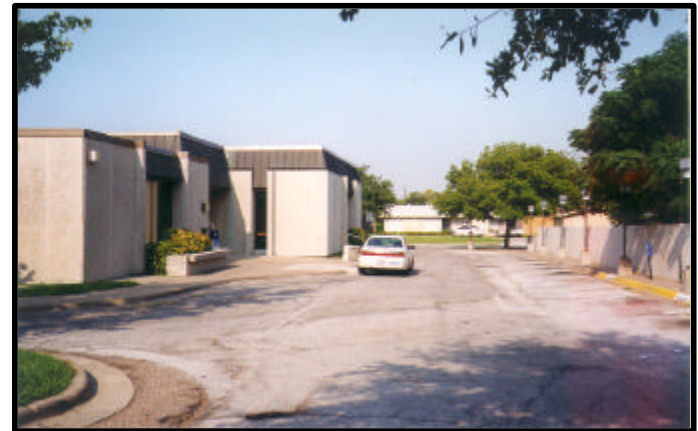
View of the parking lot

Parking surface and driveways are in poor condition. Precast fence needs removal and cleaning. Minimal ground cover, unattractive parking lots.

Secure a new site that has the capacity for a new, enlarged branch and ample parking for patrons.

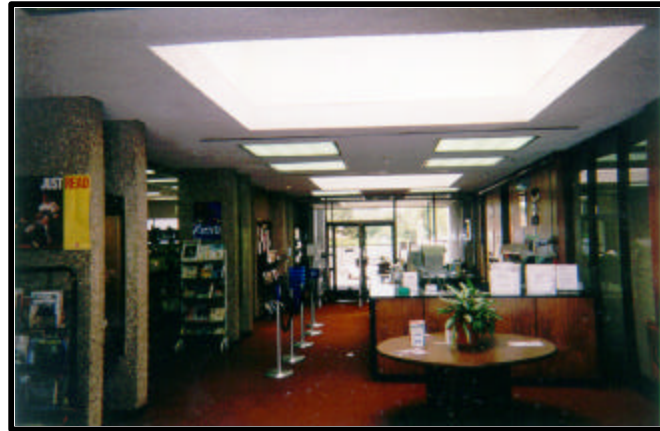
View of the circulation desk

- CIRCULATION DESK**
 - The new facility should have a well-placed central desk with good sight lines.
- AUDITORIUM**
 - The new auditorium should accommodate large public gatherings and provide for flexibility of use.

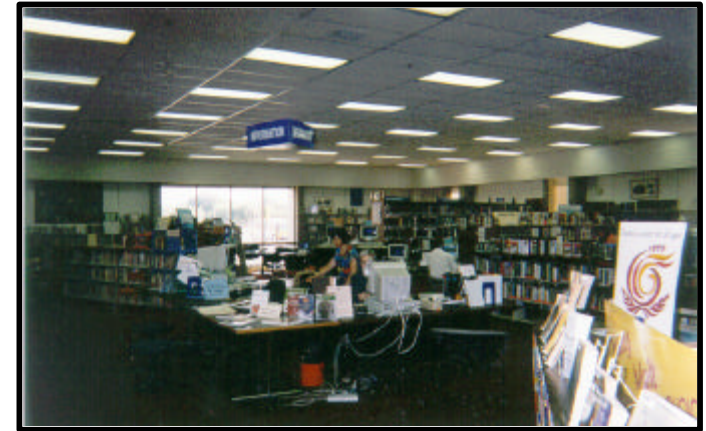
View of the reference area

- DISPLAYS**
 - The new library should provide new interactive display units and bold wall graphics.
- ADULT AREA**
 - Create a new "Reference/Computer Area" with PC's, power/data ports for laptops, and a central periodicals reading area.
