PLEASANT GROVE BRANCH LIBRARY

Building Infrastructure: Assessments & Recommendations

**PLEASANT GROVE
BRANCH LIBRARY**
Planning and Design
Assessments
& Recommendations

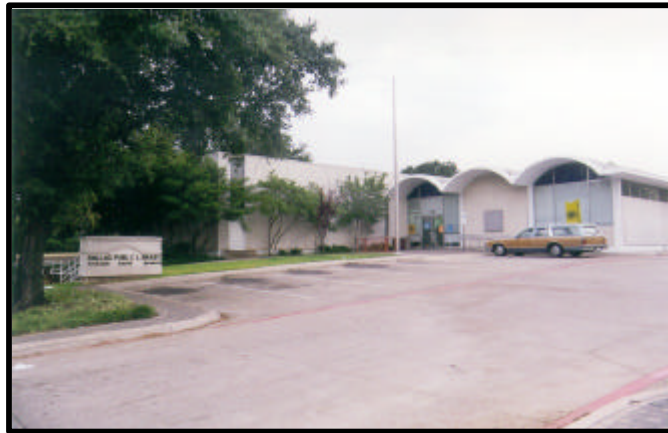
View of the entrance

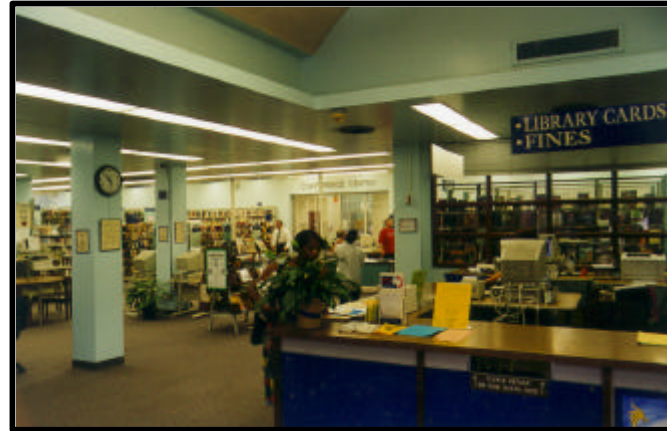
View of the circulation desk

- The placement of the desk causes a congestion of users.
- AUDITORIUM**
 - The auditorium can't be secured from the library proper.
- DISPLAYS**
 - There are no significant opportunities for displays.

- CIRCULATION DESK**
 - The new facility should have a well-placed central desk with good sight lines.
- AUDITORIUM**
 - The new auditorium should accommodate large public gatherings (min. 50 seats) and provide flexibility of use.
