POLK WISDOM BRANCH LIBRARY

Building Infrastructure: Assessments & Recommendations

**POLK WISDOM
BRANCH LIBRARY**
Planning and Design
Assessments
& Recommendations

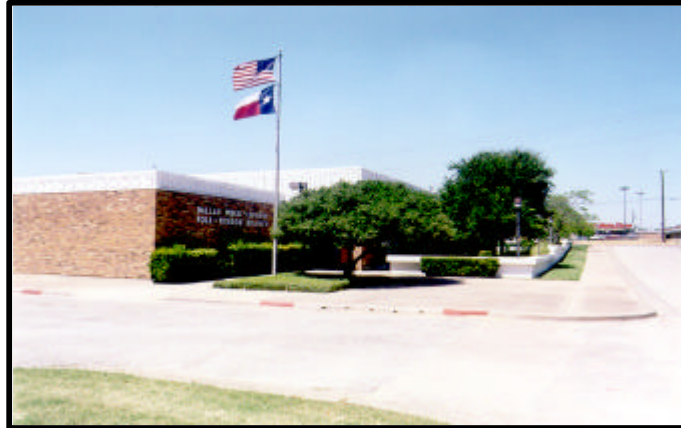
This is a low building with a bland elevation, primarily identified by signage. This building has a major abestos abatement requirement. It is a mid-sized branch in need of renovation.

View of the entrance

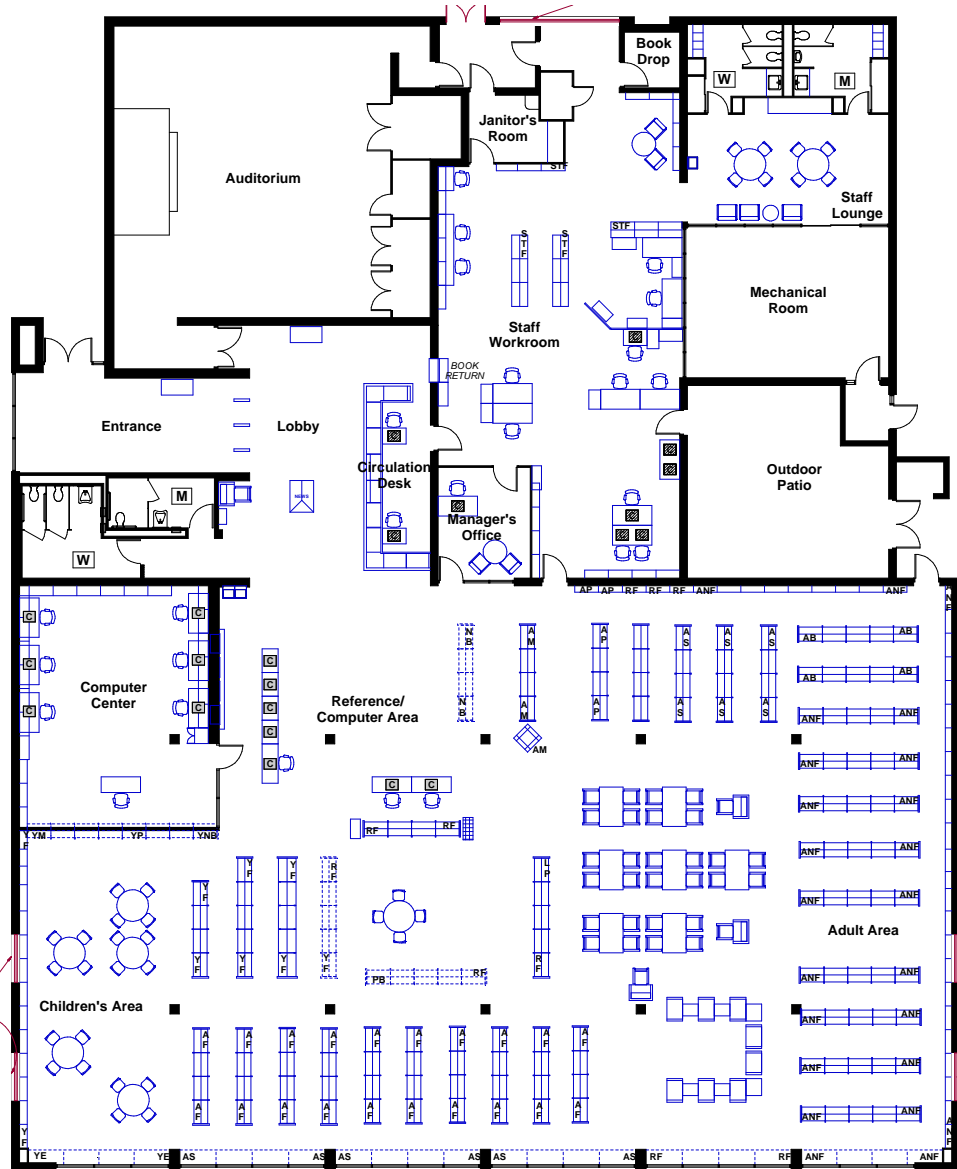
Existing Floor Plan

(Add new windows for security)

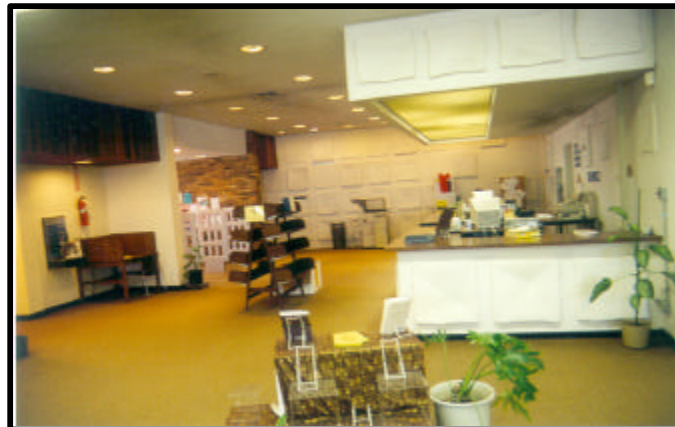
View of the circulation desk

- The circulation desk is well placed to monitor entry and to provide check-out services, but unable to monitor reading room.

- A new and expanded service point should be considered.

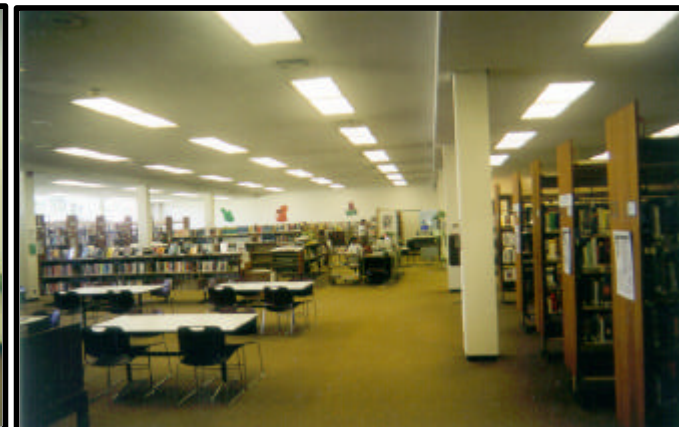
View of the reading room

- Adult periodicals are not visually prominent, and the central seating area is a bit cramped.

- Consider creating groupings of casual seating with selected collections.
