FOREST GREEN BRANCH LIBRARY

Building Infrastructure: Assessments & Recommendations

**FOREST GREEN
BRANCH LIBRARY**
Planning and Design
Assessments
& Recommendations

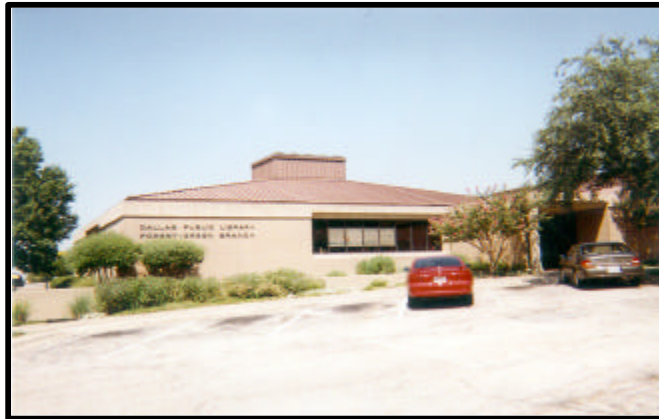
View of the entrance

- PARKING**
 - The parking is limited in quantity and remote from view.
- ENTRANCE**
 - The entrance is remote from the parking lots. The doors are too heavy for ADA compliance.

- PARKING**
 - The new facility should provide ample parking for users and staff, with accessible spaces near the entrance.
- ENTRANCE**
 - The new entrance should be welcoming, easily accessible, and clearly visible to staff.

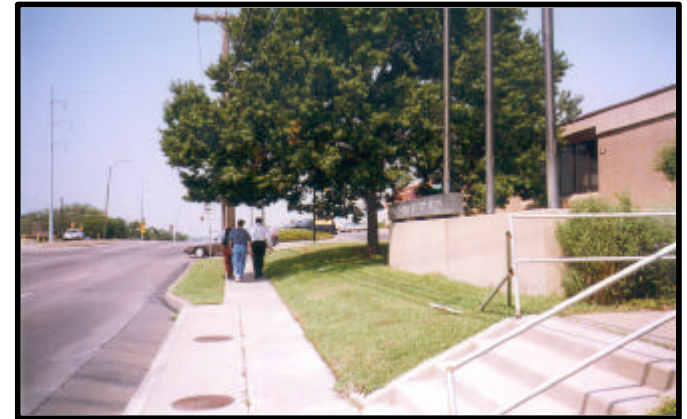
View along the street

- BUILDING EXTERIOR**
 - The small site diminishes the effect of the library's "Civic image."

- BUILDING EXTERIOR**
 - The new facility should be functionally well designed and contexturally and environmentally suitable for Dallas.

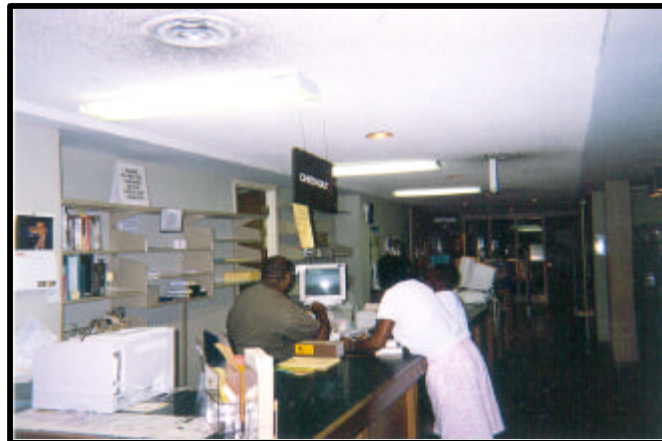
View of the circulation desk

- CIRCULATION DESK**
 - The meeting room/toilets and parking cannot be viewed from the desk. The traffic and circulation space is very tight.
- AUDITORIUM**

- CIRCULATION DESK**
 - The new facility should have a well-placed central desk with good sight lines.
- AUDITORIUM**
 - The new auditorium should accommodate large public gatherings and provide for flexibility of use.

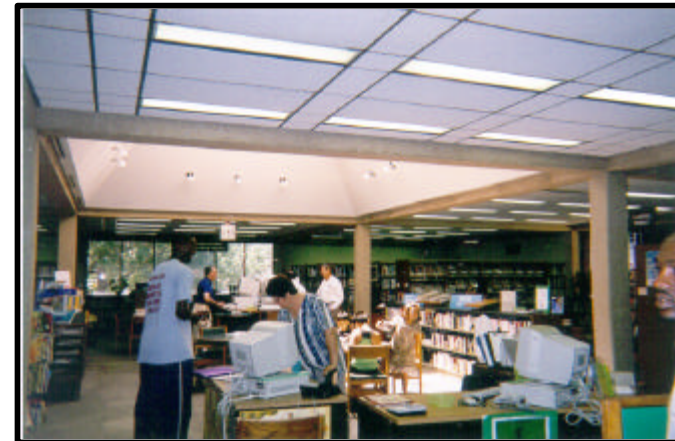
View of the reading room

- The auditorium is too small for community meetings
- DISPLAYS**
 - The displays are small and not very eye-catching
- ADULT AREA**
 - The adult area is too small and does not have enough P.C.'s or stacks.

- DISPLAYS**
 - The new library should provide new interactive display units and bold wall graphics.
- ADULT AREA**
 - Create a new "Reference/Computer Area" with PC's, power/data ports for laptops, and a central periodicals reading area.
