HAMPTON-ILLINOIS BRANCH LIBRARY

Building Infrastructure: Assessments & Recommendations

**HAMPTON-ILLINOIS
BRANCH LIBRARY**
Planning and Design
Assessments
& Recommendations

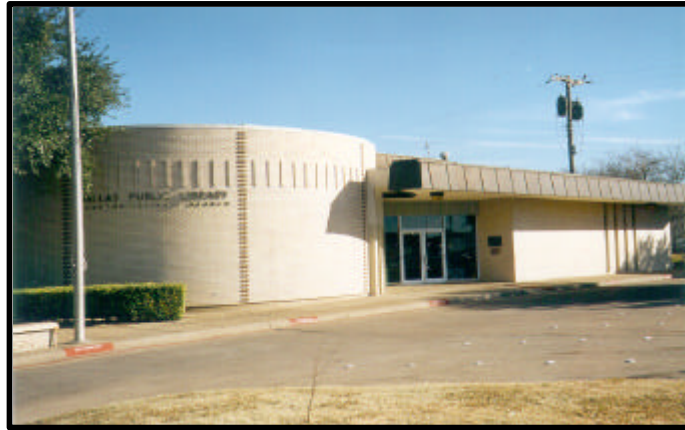
This small branch is dated and is overpowered by retail strips at the Hampton/Illinois intersection.

View of the entrance

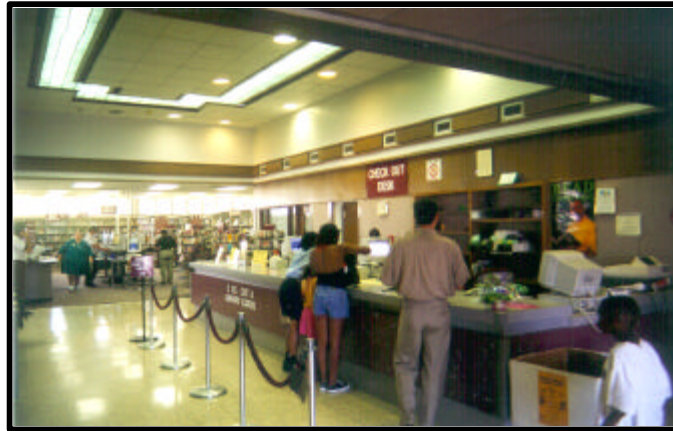
View of the circulation desk

- The meeting room cannot be secured from the library proper. There is a poor flow of patrons (check-out on the left), and desk is very shallow.

- The current desks are out-of-date and unprofessional looking.

- The new facility should have a well-placed central desk with good sight lines.

- The new library should provide high quality, accessible consultation desks.

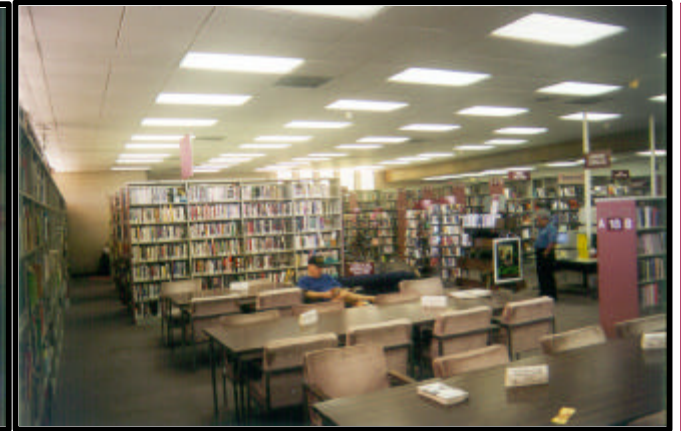
View of the reading room

- The adult area is too small and seating is extremely crowded. The book stacks are packed to capacity.

- Create a new "Reference/Computer Area" with PC's, power/data ports for laptops, and a central periodicals reading area.
