HIGHLAND HILLS BRANCH LIBRARY

Building Infrastructure: Assessments & Recommendations

HIGHLAND HILLS
BRANCH LIBRARY
Planning and Design
Assessments
& Recommendations

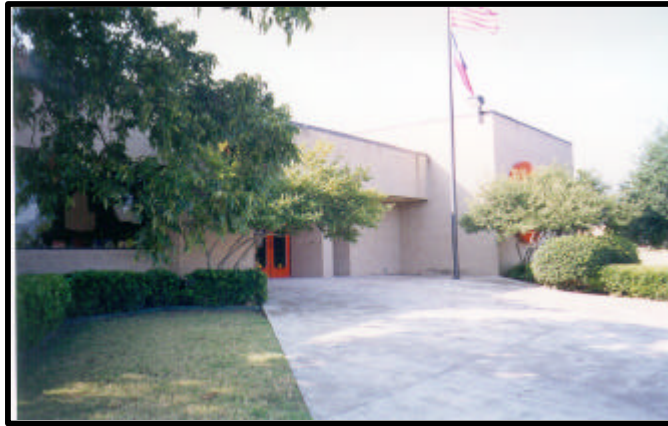
View of the entrance

- PARKING**
 - Parking is very limited and patrons must cross the driveway to use the accessible spaces.
- ENTRANCE**
 - The dual entrances consume too much area.

- PARKING**
 - The new facility should provide ample parking for users and staff, with accessible spaces near the entrance.
- ENTRANCE**
 - The new entrance should be welcoming, easily accessible, and clearly visible to staff.

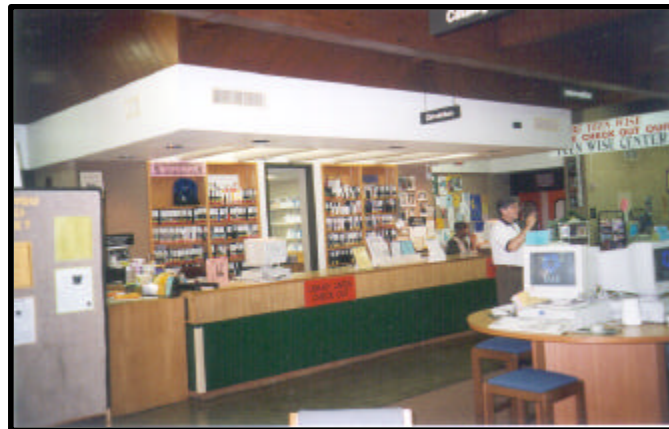
View of the circulation desk

- CIRCULATION DESK**
 - There is limited visibility into the reading room, and none to the meeting room.
- AUDITORIUM**
 - If the auditorium is secured from the library, then one can enter from the street side only.

- CIRCULATION DESK**
 - The new facility should have a well-placed central desk with good sight lines.
- AUDITORIUM**
 - The new auditorium should accommodate large public gatherings and provide for flexibility of use.

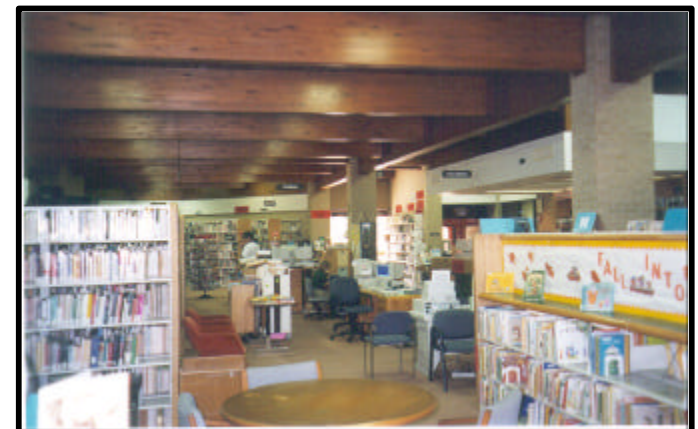
View of the reading room

- DISPLAYS**
 - The displays are small and not very exciting.
- ADULT AREA**
 - The adult seating is very limited and not near the periodicals, and the area is too small for the collections.

- DISPLAYS**
 - The new library should provide new interactive display units and bold wall graphics.
- ADULT AREA**
 - Create a new "Reference/Computer Area" with PC's, power/data ports for laptops, and a central periodicals reading area.
