LAKWOOD BRANCH LIBRARY

LAKEWOOD BRANCH LIBRARY

Building Infrastructure: Assessments & Recommendations

LAKWOOD
BRANCH LIBRARY
Planning and Design
Assessments
& Recommendations

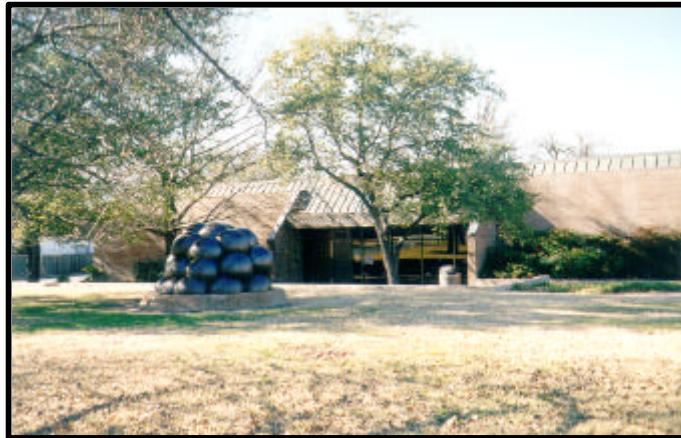
View of the entrance

The building has a residential scale, with dark brick walls and copper sloped roof. Its civic image is solid, high quality, but the entry could be more welcoming from the parking lot.

- BUILDING EXTERIOR**
 - The "Civic image" is solid, high quality, but not welcoming from the parking lot area.

- PARKING**
 - The renovated parking lots should provide accessible spaces near the entrance, and an additional 10+ spaces total.
- ENTRANCE**
 - A reconfigured entrance could be welcoming, easily accessible, and clearly visible.

- BUILDING EXTERIOR**
 - The design of the expansion could use more windows to increase the views into and from the library.

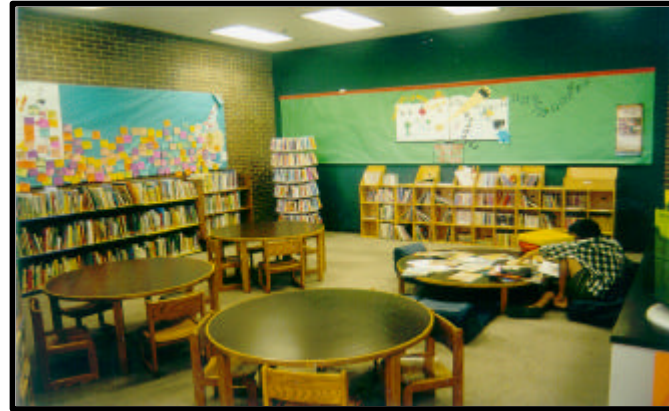
View of the children's area

- DISPLAYS**
 - The displays are small and not very eye-catching.
- ADULT AREA**
 - The adult seating area is cramped.
- CHILDREN'S AREA**
 - The teens and tots areas need definition and expansion.

- CHILDREN'S AREA**
 - The expanded library could have a dynamic "storytelling circle" area, ample computer areas, and a separate Young Adults area.
- STAFF AREA**
