MARTIN LUTHER KING, JR. BRANCH LIBRARY

Building Infrastructure: Assessments & Recommendations

MARTIN LUTHER KING JR. BRANCH LIBRARY
 Planning and Design Assessments & Recommendations

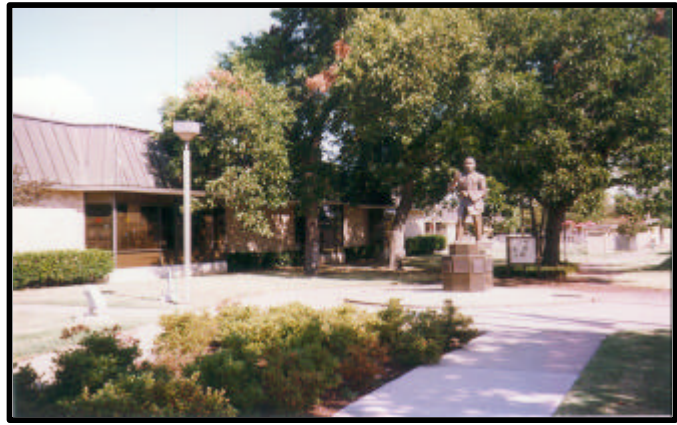
View of the entrance

- PARKING**
 - The parking lot and sidewalks are in poor condition.
- ENTRANCE**
 - The entrance is marked with a statue, but is not well defined at the building.

- PARKING**
 - Resurface the lot and repair the sidewalks.
- ENTRANCE**
 - The renovation could enliven the entry with display cases.
- CIRCULATION DESK**
 - The new design should examine the desk placement to create optimum sight lines/security.

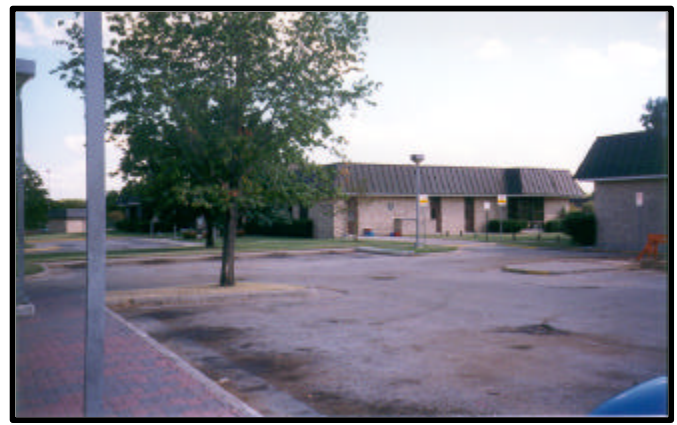
View of the parking lot

The asphalt parking lot and sidewalks are in poor condition. The narrow sidewalk at the front of the building is unsightly.

Repair and restripe the parking lot. Repair sidewalks. Redesign pathway from parking lot to main entry.

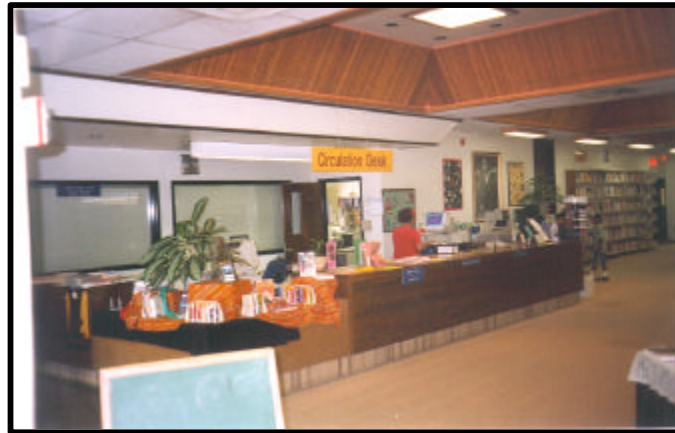
View of the circulation desk

- CIRCULATION DESK**
 - The staff at the desk cannot monitor into the high stacks at the west of the reading room.
- AUDITORIUM**
 - The auditorium can be used independently of the library, and it is in great demand.

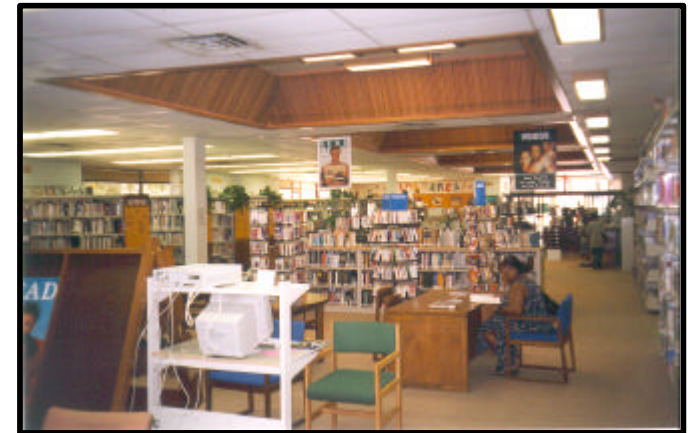
View of the reading room

- DISPLAYS**
 - The displays are small and not very eye-catching.
- ADULT AREA**
 - The adult area is undersized.
- CHILDREN'S AREA**
 - The children's area is limited in size and use by groups.

- AUDITORIUM**
 - Enlarge the auditorium in the redesign.
- DISPLAYS**
 - Add new interactive display units and bold wall graphics.
- ADULT AREA**
 - Examine the stack placement during the redesign of the interior.
