NORTH OAK CLIFF BRANCH LIBRARY

Building Infrastructure: Assessments & Recommendations

**NORTH OAK CLIFF
BRANCH LIBRARY
Planning and Design
Assessments
& Recommendations**

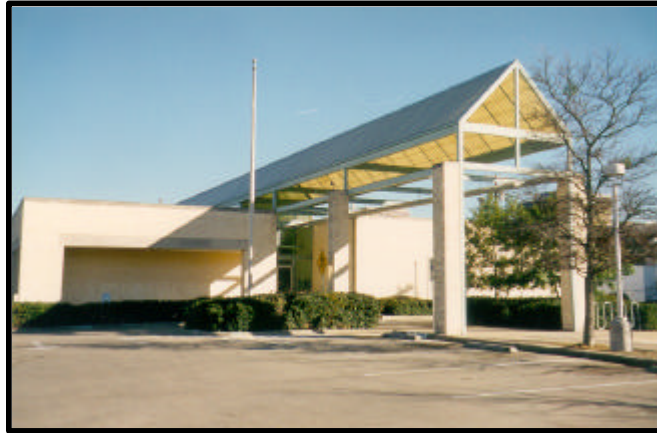
View of the entrance

- There is a dangerous situation with pedestrians crossing the driveway to get to the entrance.

- The entrance is "automobile" oriented, and it is difficult to find.

- Consider redesigning the site so that the entrance is easily accessible and clearly visible.

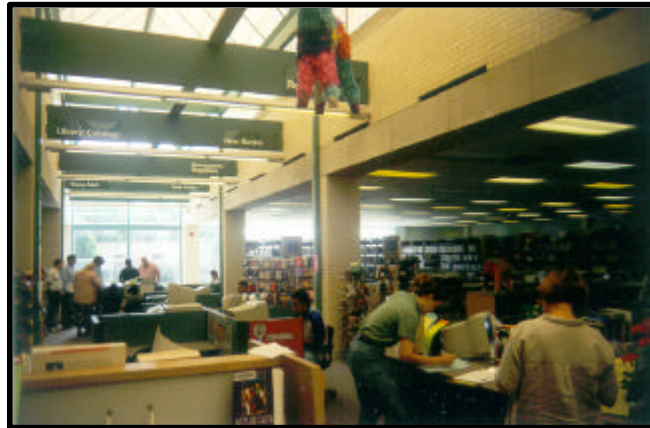
View of the circulation desk

- The circulation desk is combined with the reference desk, which confuses patrons who are seeking help.

- The current desks are combined and are in need of an additional check-out station.

- The new design should reexamine the placement and function of both the circulation and reference desks.

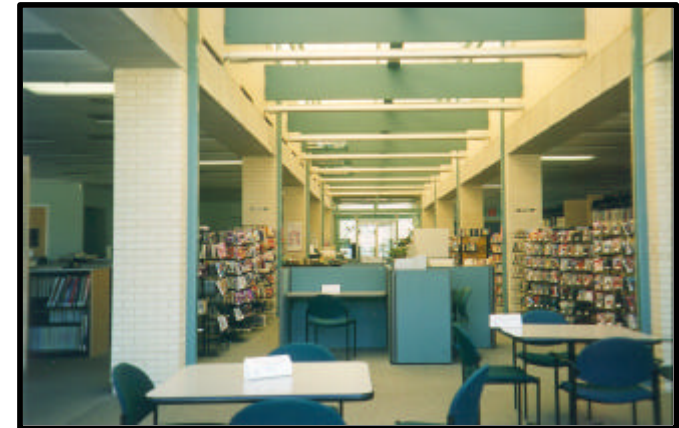
View of the reading room

- The adult seating is at a premium.

- Increase the amount and variety of adult seating, and create a periodicals reading area.
