PRESTON ROYAL BRANCH LIBRARY

Building Infrastructure: Assessments & Recommendations

**PRESTON ROYAL
BRANCH LIBRARY**
Planning and Design
Assessments
& Recommendations

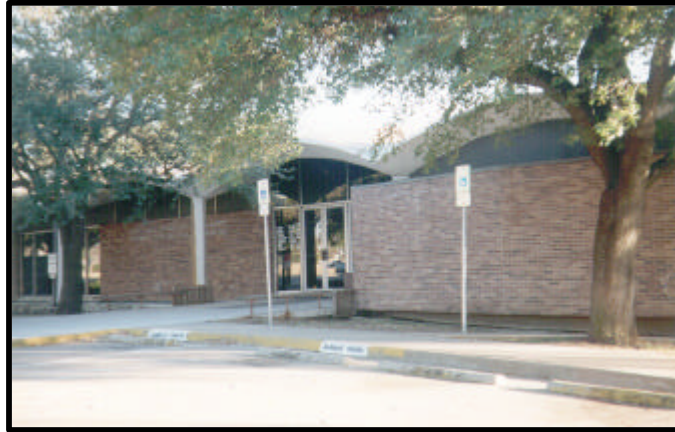
The building has a residential scale, and has vaulted roofs and a grove of trees. The signage is small and in shadow.

View of the entrance

- BUILDING EXTERIOR**
 - Replace the exterior library signage with bolder, more visible graphics.

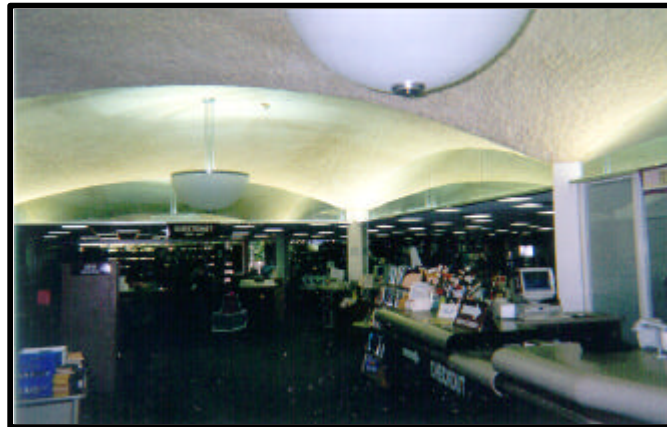
View of the circulation desk

- PARKING**
 - The south parking lot requires two more accessible spaces.
- ENTRANCE**
 - The entrance is well sized.
- CIRCULATION DESK**
 - The circulation desk is small and cramped, and the transaction lines interfere with the entry.

- CIRCULATION DESK**
 - The renovated facility could have a larger, well placed central desk with better sight lines.
- AUDITORIUM**
 - The auditorium needs general renovations and improved lighting.

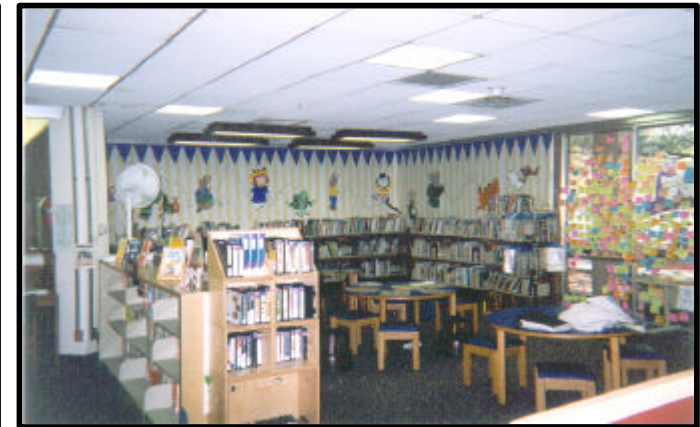
View of the children's area

- ADULT AREA**
 - The adult seating and collections are in an awkward arrangement.
- CHILDREN'S AREA**
 - The children's area is fairly well defined, but is tired in appearance.

- CHILDREN'S AREA**
 - The renovated library could have a dynamic "storytelling circle" area, and a separate Young Adults area.
- STAFF AREA**
 - The renovated staff area should have ample sized, ergonomic furnishings, with visibility to the public areas.
