RENNER-FRANKFORD BRANCH LIBRARY

Building Infrastructure: Assessments & Recommendations

**RENNER-FRANKFORD
BRANCH LIBRARY**
Planning and Design
Assessments
& Recommendations

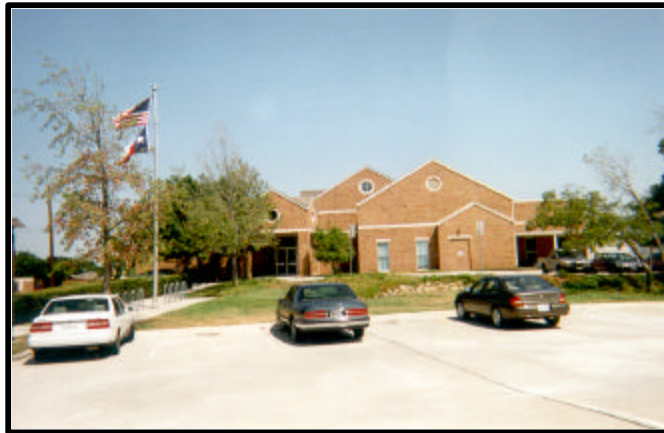
This library uses traditional imagery with pitched roofs and dormers to create its civic image. The entry is clearly marked and the upper parking terrace is well landscaped.

View of the entrance

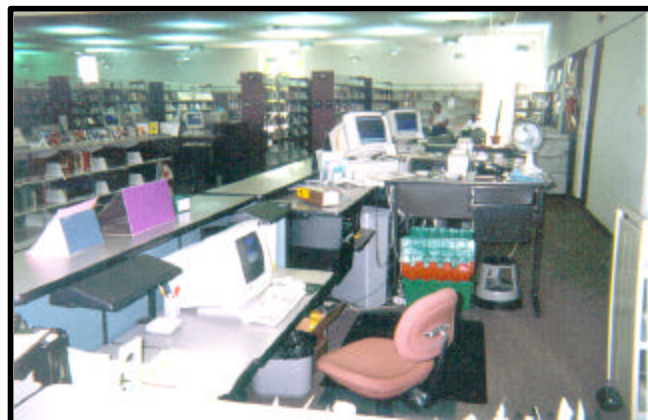
View of the circulation desk

- PARKING**
- Some parking spaces are not striped.
- ENTRANCE**
- Entrance is clearly visible.
- CIRCULATION DESK**
- The path of people leaving the library conflicts with the transaction lines at the desk.

- PARKING**
- Renovate and restripe the asphalt parking surface.
- ENTRANCE**
- No action required.
- CIRCULATION DESK**
- Review and improve patron transaction/circulation patterns.

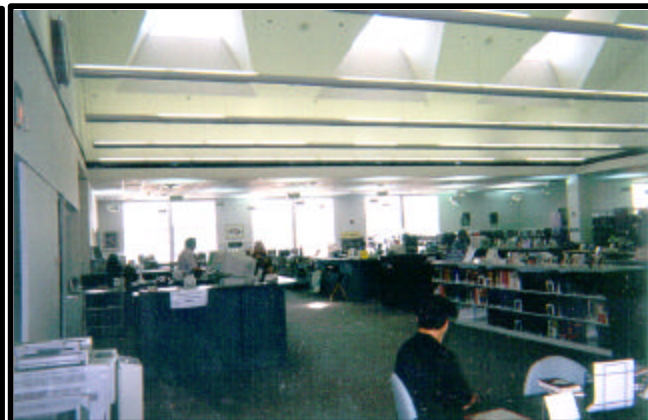
View of the reading room

- The combination of Adult periodicals and casual seating works well in concept, but the location is too remote for such popular materials.
- CHILDREN'S AREA**

- AUDITORIUM**
- No action required.
- DISPLAYS**
- Add interactive display units and bold wall graphics.
- ADULT AREA**
- Create a new central "Reference/Computer Area" in the redesign.
