SKILLMAN SOUTHWESTERN BRANCH LIBRARY

Building Infrastructure: Assessments & Recommendations

**SKILLMAN
SOUTHWESTERN
BRANCH LIBRARY**
Planning and Design
Assessments
& Recommendations

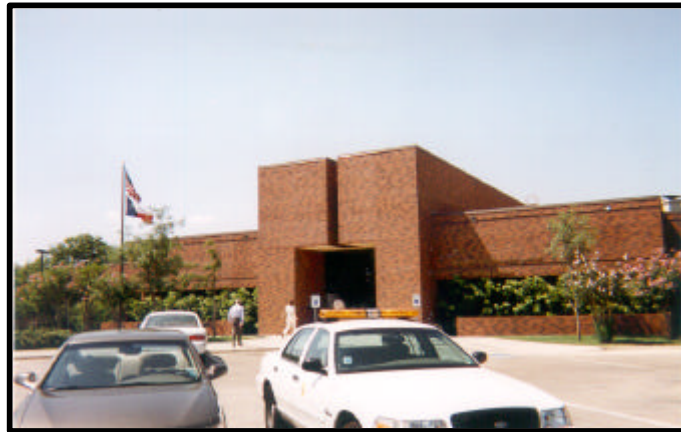
This branch is a neutral red brick building, and its signage is small and difficult to read. It is a symmetrical building sited in a diagonal relationship to the corner.

View of the entrance

- The entrance is prominent and imposing.

- Consider well placed shade tree plantings to soften facade.

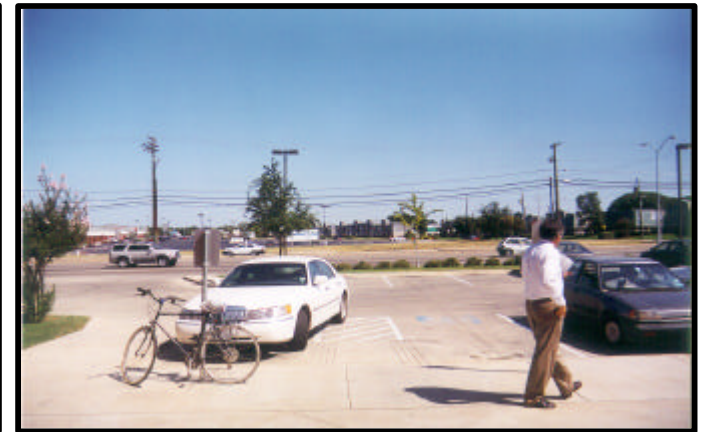
View of the parking lot

- The parking is inadequate at peak times.
- The parking lot is in good condition.

- Review parking situation in coming years when the lot needs to be replaced.

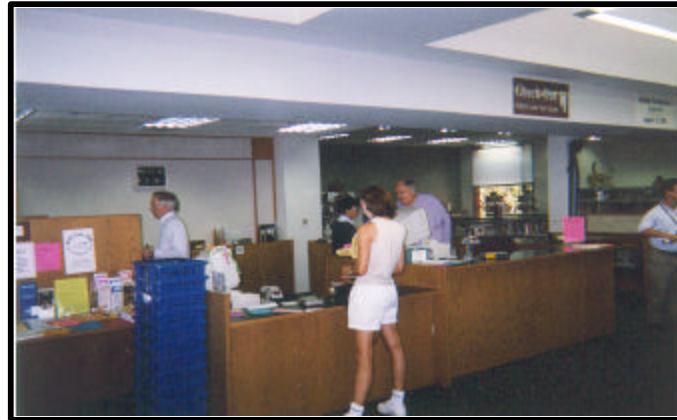
View of the circulation desk

- The placement of the desk conflicts with entry/exit traffic.

- Consider redesign of circulation desk.

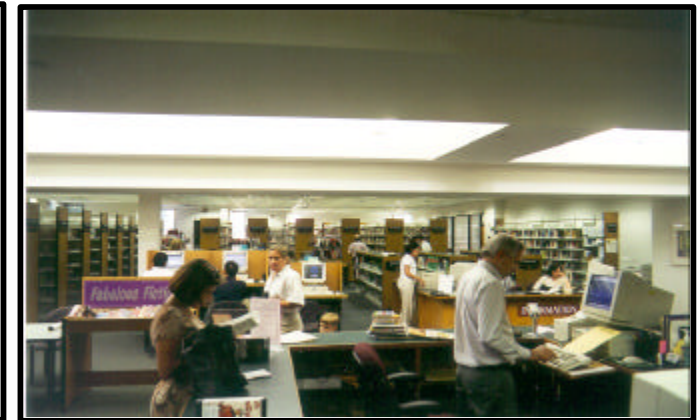
View of the reference desk and reading area

- The service desks are located in close proximity to the entrance, which causes conflicts with the entry/exit traffic.

- Redesign service desks to improve patron circulation flow.
