WALNUT HILL BRANCH LIBRARY

Building Infrastructure: Assessments & Recommendations

WALNUT HILL
BRANCH LIBRARY
Planning and Design
Assessments
& Recommendations

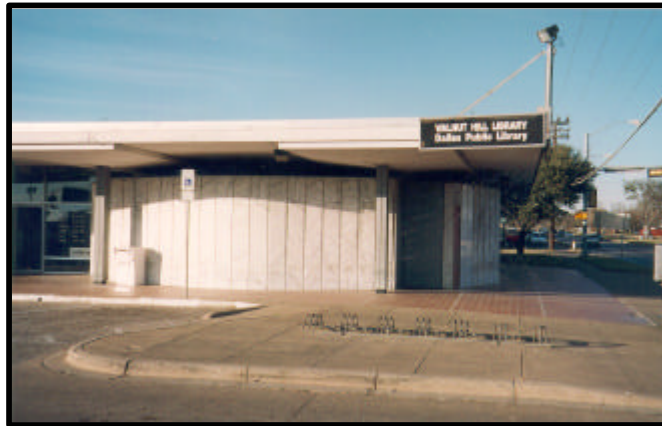
The building is a low, one story pavilion with marble cladding - its civic image is weak, and the building is over-powered by adjacent retail areas.

View of the entrance

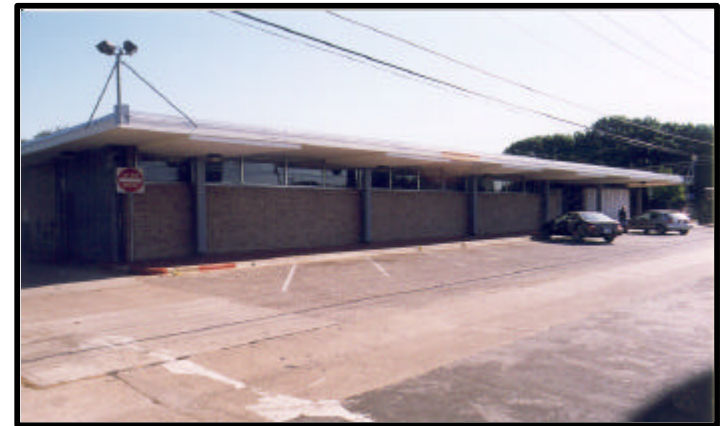
View along the street

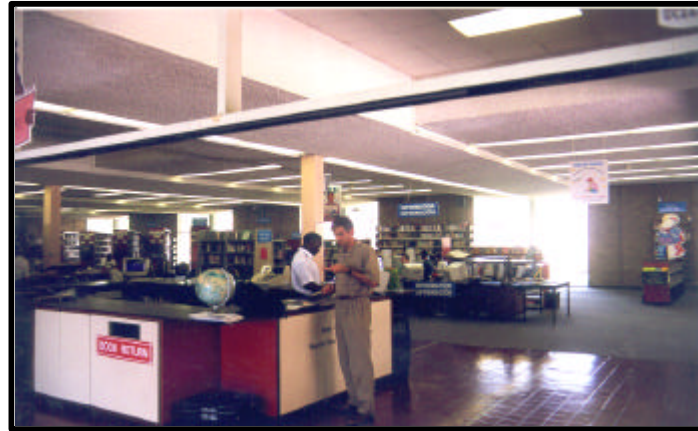
View of the circulation desk

- CIRCULATION DESK**
 - The circulation desk is remote from the staff area.
- AUDITORIUM**
 - The auditorium is oddly configured.
- DISPLAYS**
 - The displays are limited and small.

- CIRCULATION DESK**
 - The new facility should have a well-placed central desk with good sight lines.
- AUDITORIUM**
 - The new auditorium should accommodate large public gatherings and provide for flexibility of use.

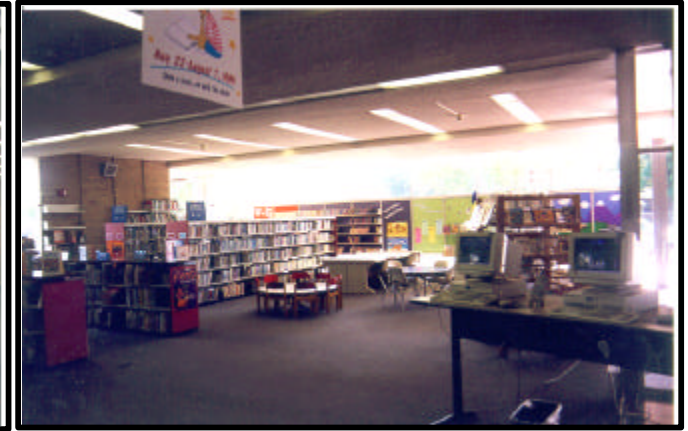
View of the reading room

- ADULT AREA**
 - The adult seating is too tightly spaced to be comfortable.
- CHILDREN'S AREA**
 - The children's area is reasonably identified, but popular activities and computers are jammed into corners.

- DISPLAYS**
 - The new library should provide new interactive display units and bold wall graphics.
- ADULT AREA**
 - Create a new "Reference/Computer Area" with PC's, power/data ports for laptops, and a central periodicals reading area.
