# KLEBERG-RYLIE BRANCH LIBRARY

## Building Infrastructure: Assessments & Recommendations

**KLEBERG-RYLIE  
BRANCH LIBRARY  
Planning and Design  
Assessments  
& Recommendations**

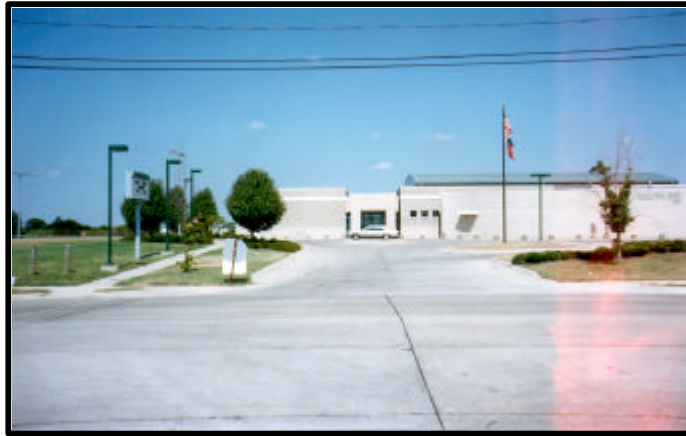
View of the entrance

- PARKING**
  - The parking lot could use more landscaping. The lot is not visible from within the building.
- ENTRANCE**
  - The exterior axial entry could be accented with display banners..

- PARKING**
  - Add windows at the office area.
- ENTRANCE**
  - Add display banners
- CIRCULATION DESK**
  - Adjust the design of the desk to increase visibility and proximity to the entrance.

- BUILDING EXTERIOR**
  - Exterior banners and new windows could help the library look more inviting from the exterior.

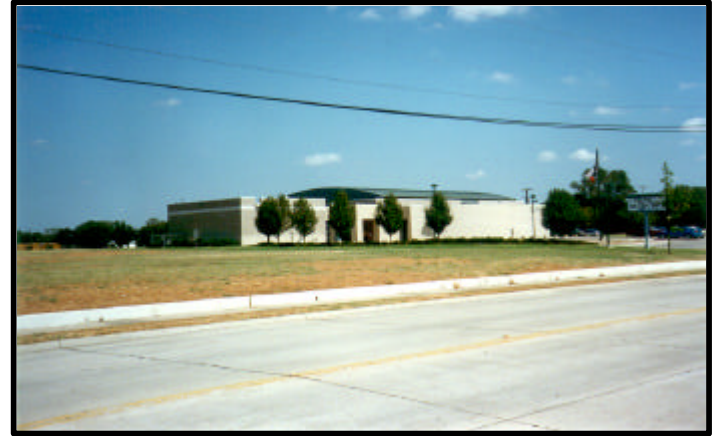
Set within an area of transition of rural to suburban uses, this relatively new branch could use additional landscaping and a highlighting of its entrance to enhance its civic image.

View along the street

Review landscape plans and provide enhancements and better maintenance (i.e. irrigation) of existing plants. Redesign sign graphics.

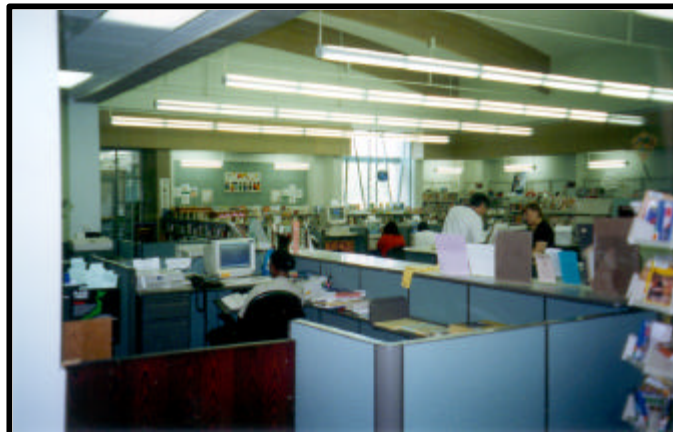
View of the circulation desk

- CIRCULATION DESK**
  - The desk is recessed from the entry line of sight, and is remote from entry.
- AUDITORIUM**
  - The meeting room is small, but can be used independent of the library hours of operation.

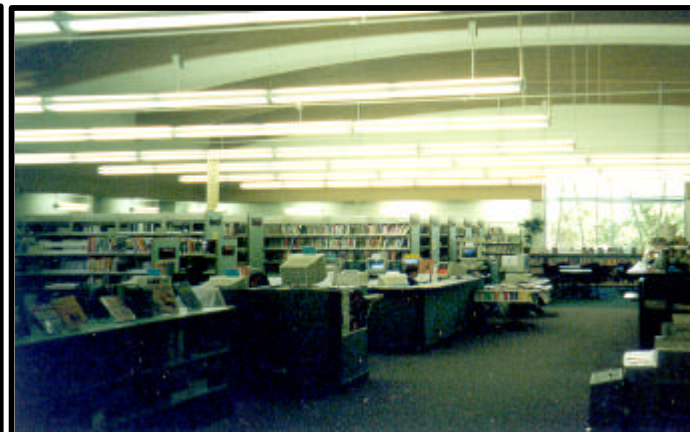
View of the reading room

- DISPLAYS**
  - The displays are small and not very eye-catching.
- ADULT AREA**
  - There is insufficient seating for adults.
- CHILDREN'S AREA**
  - The circulation desk could be bypassed as one exits this area.

- SERVICE DESKS**
  - Seating is needed adjacent to the reference desk.
- FURNITURE**
  - There is a lack of variety in seating types (i.e. quiet alcove vs. grouped tables.)

- AUDITORIUM**
  - No action required.
- DISPLAYS**
  - The library should consider new interactive display units and bold wall graphics.
- ADULT AREA**
  - Adjust the current plan to accept additional adult seating (4 to 6 seats).

- GROUP STUDY/CONFERENCE**
  - No action required.
- SERVICE DESKS**
  - Redesign reference desk area to make room for seating.
- FURNITURE**
  - Increase the variety of seating choices in the branch.
