LAKWOOD BRANCH LIBRARY

LAKEWOOD BRANCH LIBRARY

Building Infrastructure: Assessments & Recommendations

LAKWOOD
BRANCH LIBRARY
Planning and Design
Assessments
& Recommendations

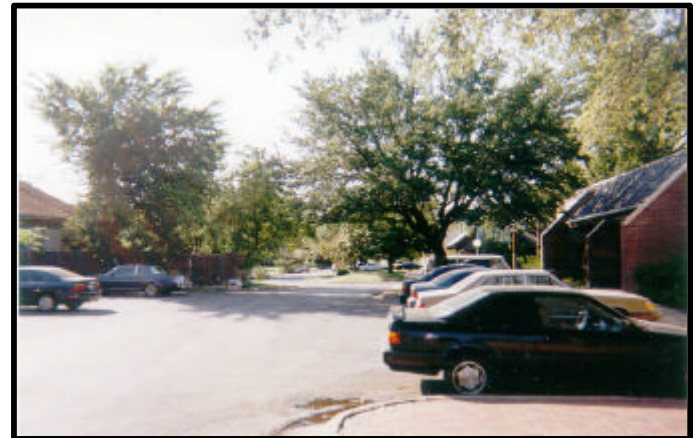
View of the entrance

The building has a residential scale, with dark brick walls and copper sloped roof. Its civic image is solid, high quality, but the entry could be more welcoming from the parking lot.
