PARK FOREST BRANCH LIBRARY

Building Infrastructure: Assessments & Recommendations

**PARK FOREST
BRANCH LIBRARY**
Planning and Design
Assessments
& Recommendations

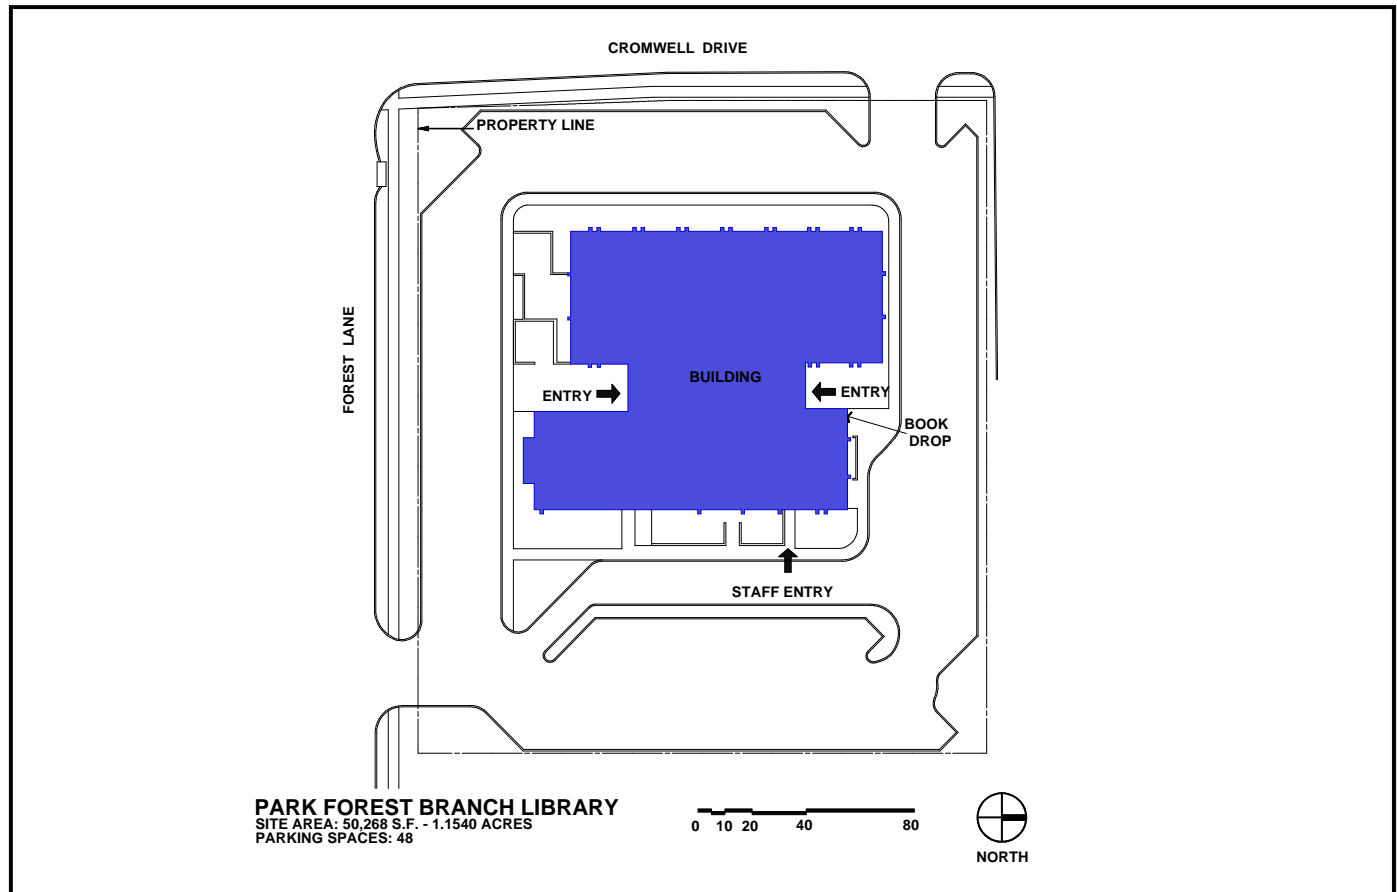
PARK FOREST BRANCH LIBRARY
SITE AREA: 50,268 S.F. - 1.1540 ACRES
PARKING SPACES: 48

Parking surface and driveways are in poor condition. Precast fence needs removal and cleaning. Minimal ground cover, unattractive parking lots.
