PRESTON ROYAL BRANCH LIBRARY

Building Infrastructure: Assessments & Recommendations

**PRESTON ROYAL
BRANCH LIBRARY**
Planning and Design
Assessments
& Recommendations

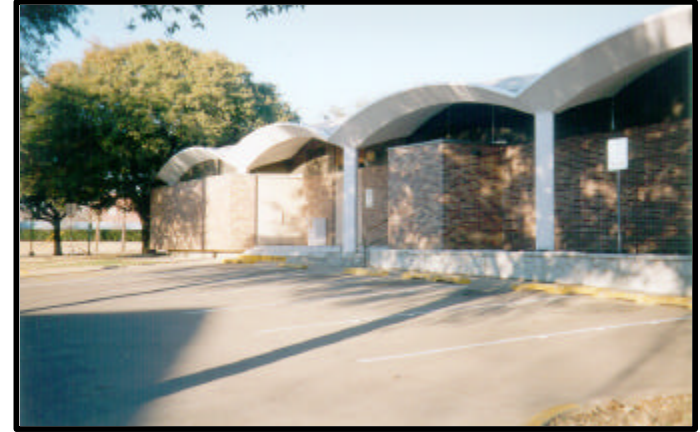
The building has a residential scale, and has vaulted roofs and a grove of trees. The signage is small and in shadow.

View along the street

- BUILDING EXTERIOR**
 - Replace the exterior library signage with bolder, more visible graphics.
